Navajo Abandoned Uranium Mine

Site Screen Report

**Mine Name: Hoskie Tso No. 1
Mine ID: 852**

Weston Solutions, Inc.

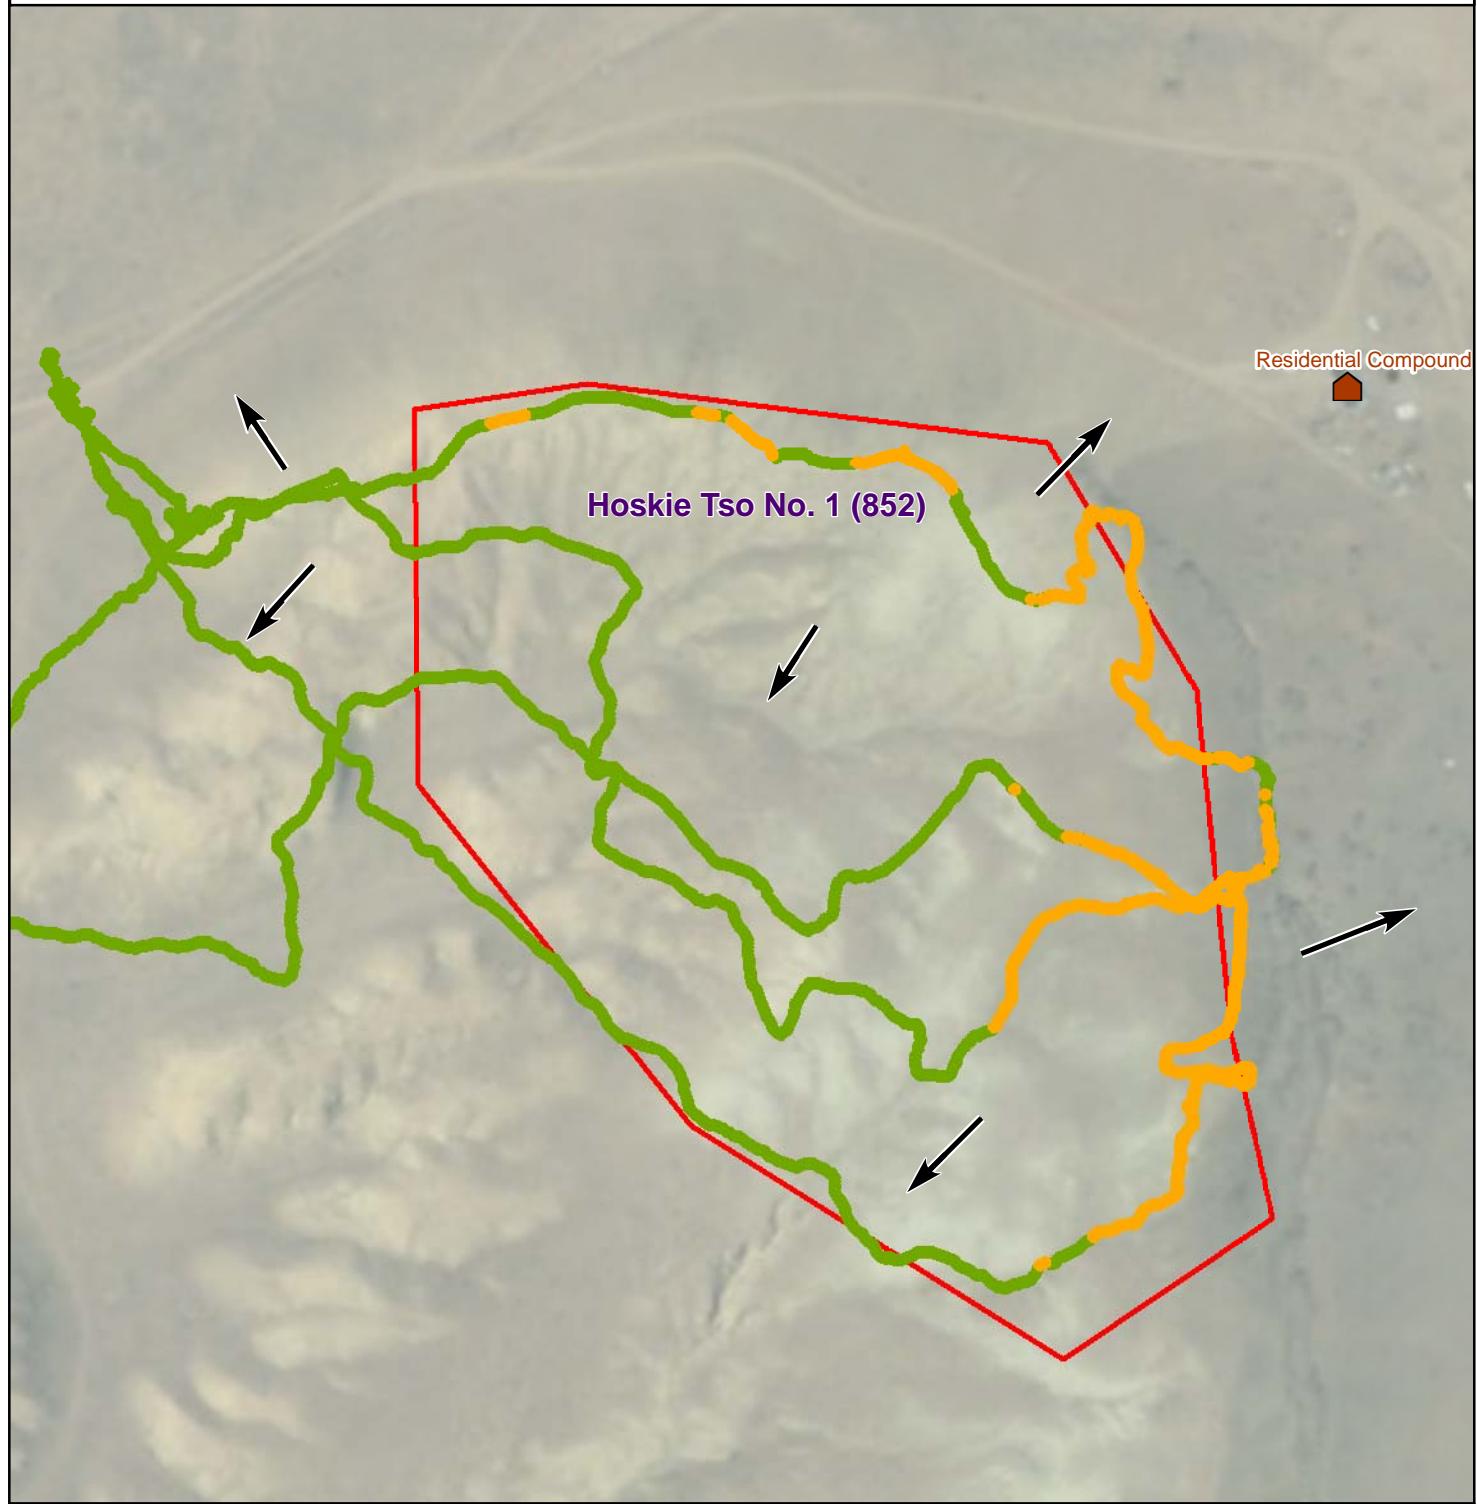
Figure 1 - Gamma Radiation Measurements, Above Two Times Background
Hoskie Tso No. 1 (852)
Indian Wells Chapter, Navajo Nation

A total of 4,302 gamma radiation measurements were collected from the mine site, ranging from 4,727 cpm to 209,442 cpm. The measurements are represented in Figures 1 and 2.
